WALL PANEL CONNECTION DETAIL

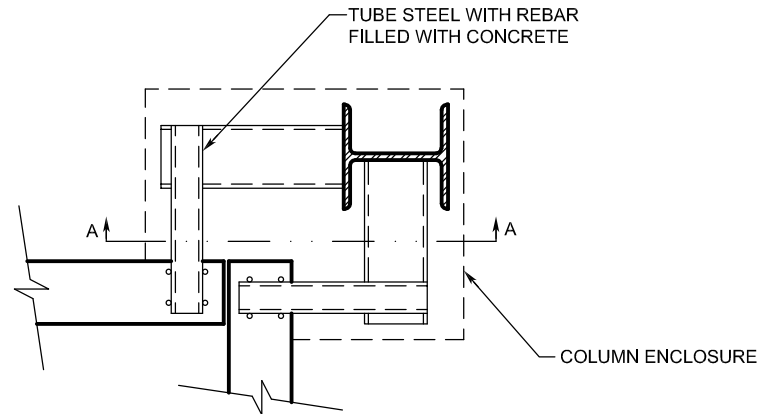
INTERIOR CORNER BEARING

NOTE: THE ENGINEER OF RECORD SHALL CHECK THE COLUMN FOR LOCALIZED BUCKLING
